An Investigation into a Newly-Discovered Scheme of 18th Century Wall-Paintings in the East Staircase at Stowe House.

By Rhiannon Clarricoates MA BA (Hons) ACR

Stowe House and the Architectural Development of the East Staircase

Preliminary Architectural Paint Research in the East Staircase

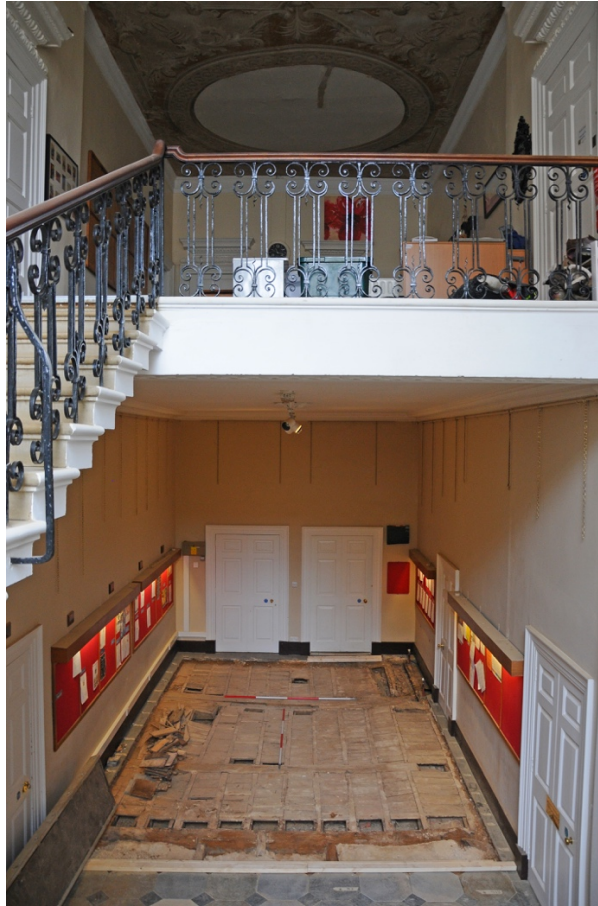
Figure 3: An image showing the original position of the staircase beneath the floor in the East Corridor ©TJC Heritage Ltd 2015, reproduced with permission.

The Western and Eastern state apartments were extended around c1740. An archaeological investigation¹ in the East corridor confirmed that the east staircase was previously located to the west end of the east corridor, and when the external wall was moved east-wards, the existing staircase was removed and a stone cantilever staircase was constructed in its current position (see figures 3 and 4). Despite the East and West staircases being symmetrical in design and their relative modesty today, from 1762 the East stair was referred to as the Grand Staircase, alluding to a greater significance or elevated status.

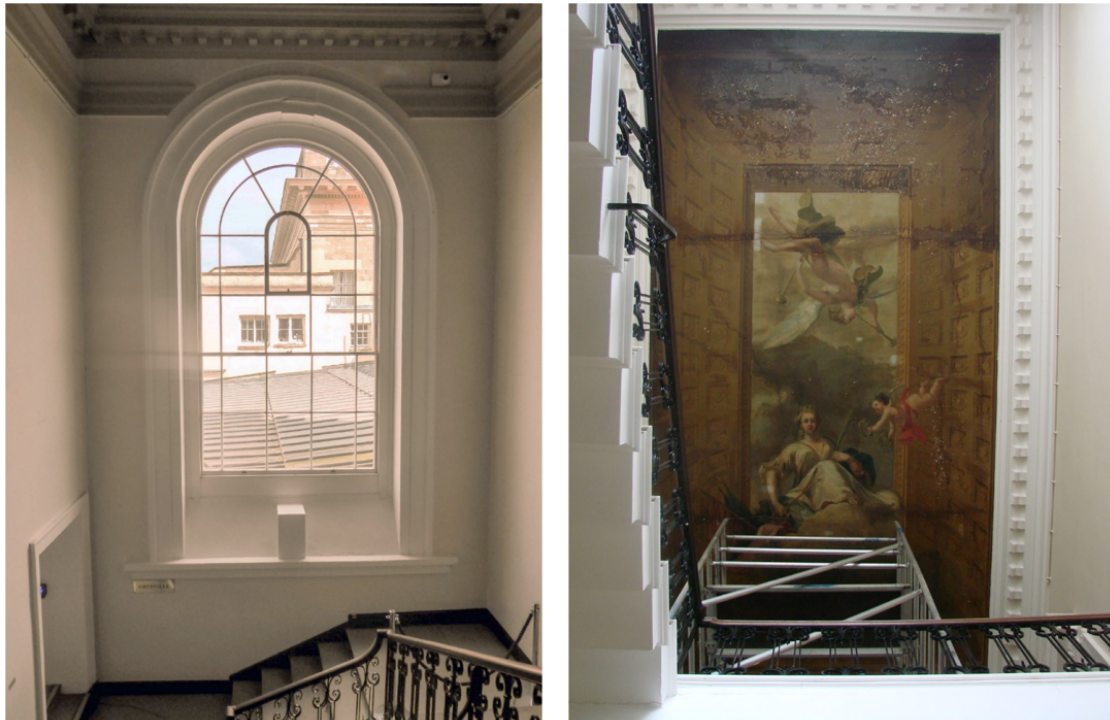
Figure 5: General view of the East Staircase and the *Fame and Victory* ceiling above, before conservation © Hirst Conservation Ltd, 2016.

The East staircase as it stands today rises to the second floor from the East corridor, with the large rectangular allegory of *Fame and Victory* to the West end over the staircase, which is painted in oil on plaster and is rich in colour (see figure 5). It was painted by Francesco Sletter (1685-1775), a Venetian artist who lived and worked in England from an early age. In contrast, the smaller ceiling above the upper landing is decorated with trompe l'oeil in brunaille/grisaille technique, although the central circular composition is missing and unrecorded (see figure 6).

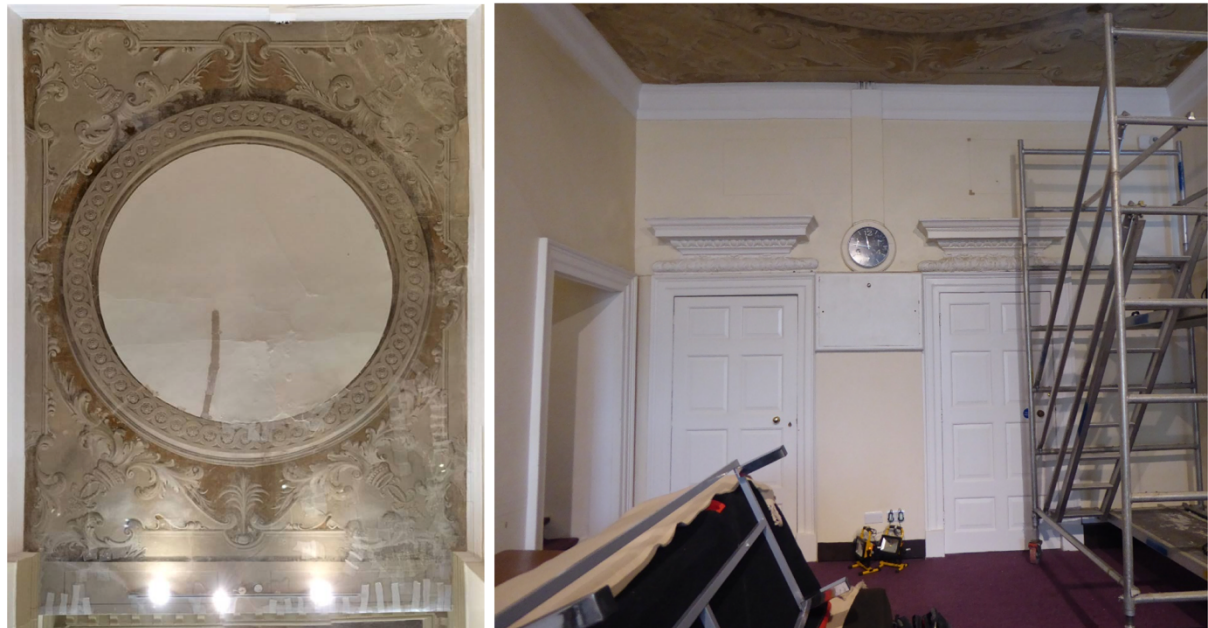
Figure 6: A general view of the upper landing and the trompe l'oeil ceiling above © Hirst Conservation Ltd.

The varying appearance of the adjacent ceilings against the plain, off-white backdrop of the walls and cornice, make the compositions visually discordant. It is not known with certainty who painted

the ceiling above the landing, nor if it is coeval with the Sleter ceiling painting c1740, and it has been suggested by Bevington that the trompe l'oeil ceiling could be a remnant of Kent's earlier fabric, framing the earlier staircase to the West end of the East corridor.

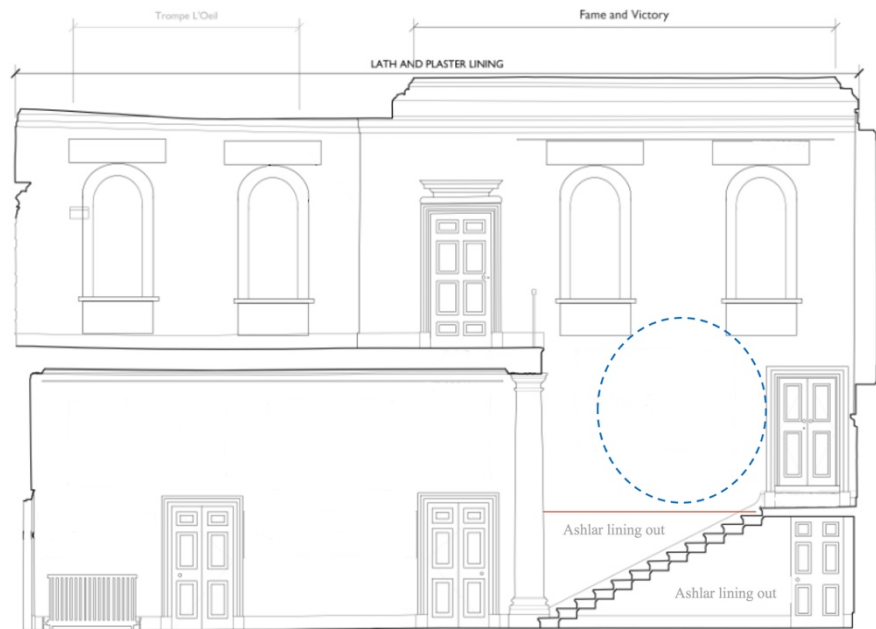
Figure 9: An illustration showing the approximate layout of the composition to the North wall © Hirst Conservation Ltd. Architectural drawings supplied by Purcell, architects to Stowe House Preservation Trust

Further to the initial discovery, a more robust phase of investigation was carried out, to establish the extent of the painted decoration and its likely composition.ⁱⁱ Using a raking light, the walls were examined and pencils were used to mark out the composition, where visible. Similar outlines were evident across the walls from skirting level up to cornice height, from the upper landing, down through the staircase and terminating at the pilaster at the foot of the stairs, suggesting the presence of a series of painted niches, cartouches, overdoor panels, architectural pediments and ashlar block-work (see figures 9 and 10). Interestingly, the position of the wall paintings in relation to the doors suggested that some of the door openings are later.

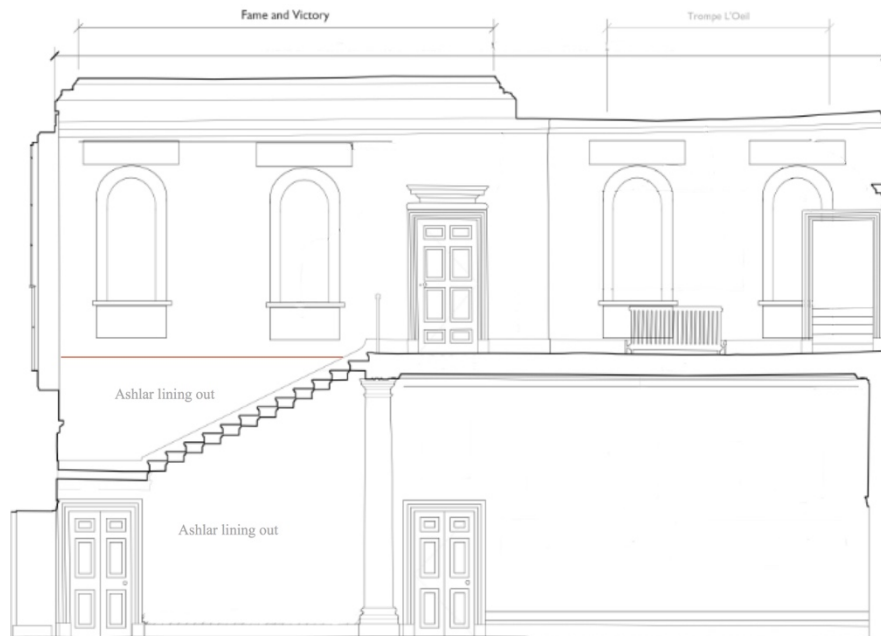
Figure 10: An illustration showing the approximate layout of the composition to the South wall. © Hirst Conservation Ltd. Architectural drawings supplied by Purcell, architects to Stowe House Preservation Trust

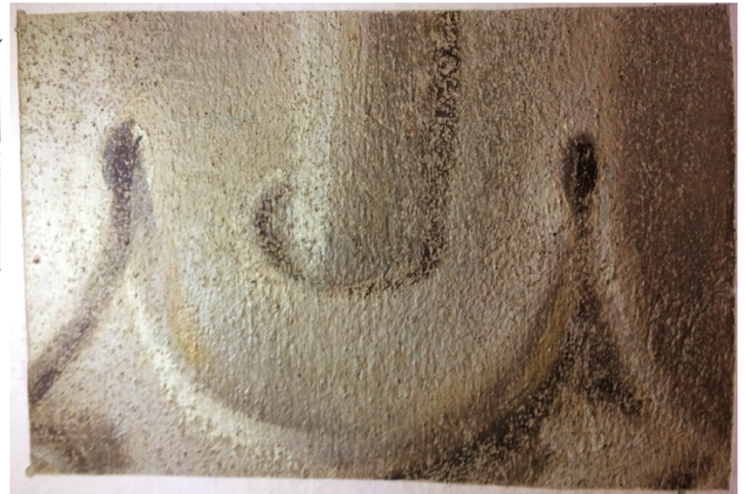
Figure 12: (above right) The revealed section of trompe l'oeil painting, possibly the shaft of a pole, and (above left) an illustration indicating its location on the South wall of the East Staircase (not to scale). © Hirst Conservation Ltd. Architectural drawings supplied by Purcell, architects to Stowe House Preservation Trust

A two-stage mechanical process using scalpels enabled the painstaking removal of the layers of overpaint. The first tantalising find was the location of architectural detailing of a niche on the south wall of the upper landing (figure 11), followed by what appears to be a shaft of a pole to the south wall of the staircase (figure 12) and a figure within a niche on the north wall of the upper landing (figure 13).

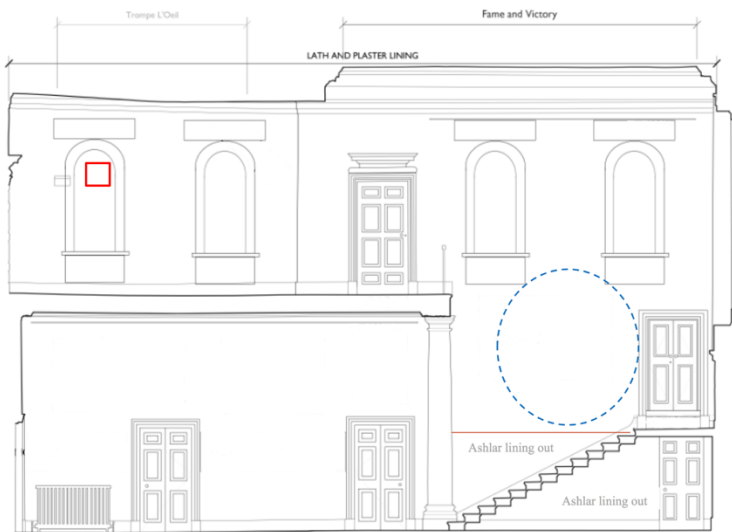
Figure 13: (above right) A section of trompe l'oeil painting within the outline of the niche, depicting a female figure, and (above left) an illustration indicating its location on the North wall of the upper landing (not to scale). © Hirst Conservation Ltd. Architectural drawings supplied by Purcell, architects to Stowe House Preservation Trust

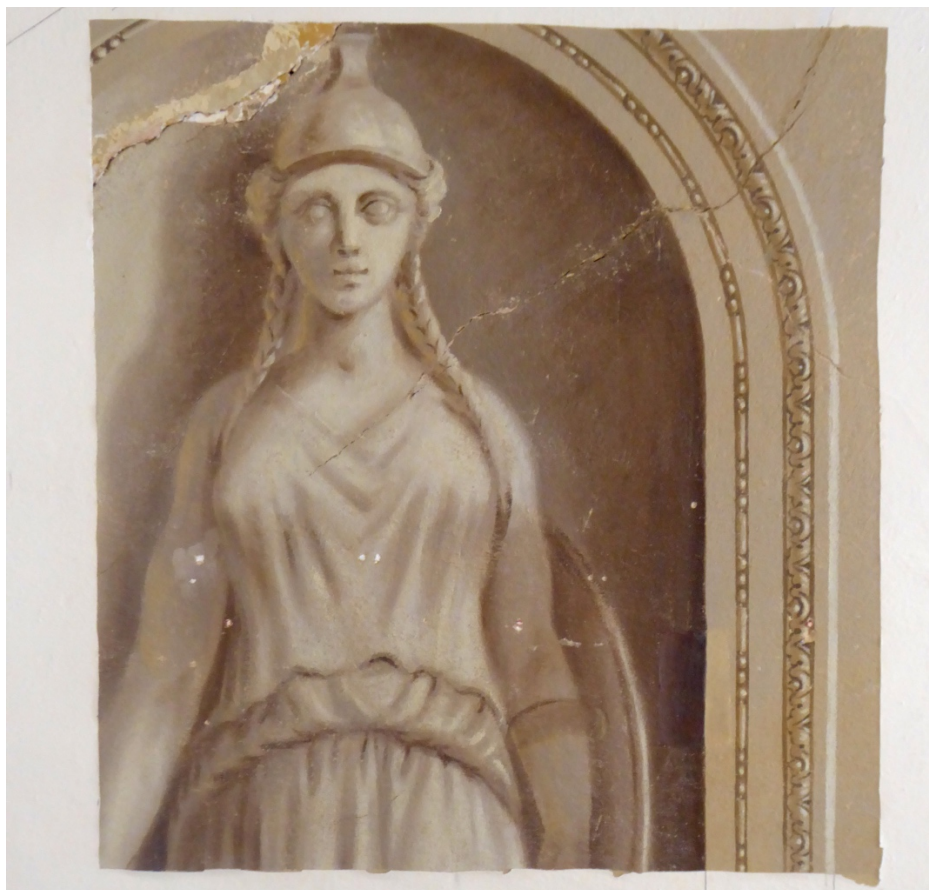
In an attempt to better appraise the significance and condition of the wall paintings and to assess the feasibility of uncovering on a wider scale, a section of the painting, approximately 1msq in area, was uncovered (see figure 15). This exposure revealed a larger than life-sized figure, possibly of Minerva, standing in a niche, wearing a helmet, with her long hair tied in two braids. She carries a shield on her left arm and is holding what appears to be a staff or spear by her right side. Although she is the Roman goddess of wisdom, Minerva's iconographic association with strategic warfare and her military dress may have contributed to the description of the walls being adorned with 'war-like' pieces.

Figure 15: The 1sqm uncovering of the figure of Minerva in a fictive niche on the North wall of the upper landing © Hirst Conservation Ltd, 2016

The uncovering technique was slow but effective, although, depending on the texture of the plaster substrate, some areas of over-paint were much easier to remove than others. The condition of the paintings beneath is generally very good, with very little evidence of abrasion, dirt or past intervention. There are a number of small holes evident on the surface of the painting, at

approximately the same height, some of which were filled with rawl plugs, which are as a result of pictures being hung on the walls. Some of these holes were not evident prior to uncovering as they were defunct fittings that had been filled and decorated over. Two large diagonal cracks were also revealed during the course of uncovering, which were not previously apparent, as they had been repeatedly filled and scraped back prior to each subsequent scheme of redecoration, masking the true condition beneath. The cracks are likely to be as a result of settlement and appear to correspond with cracking seen to the other side of the wall.

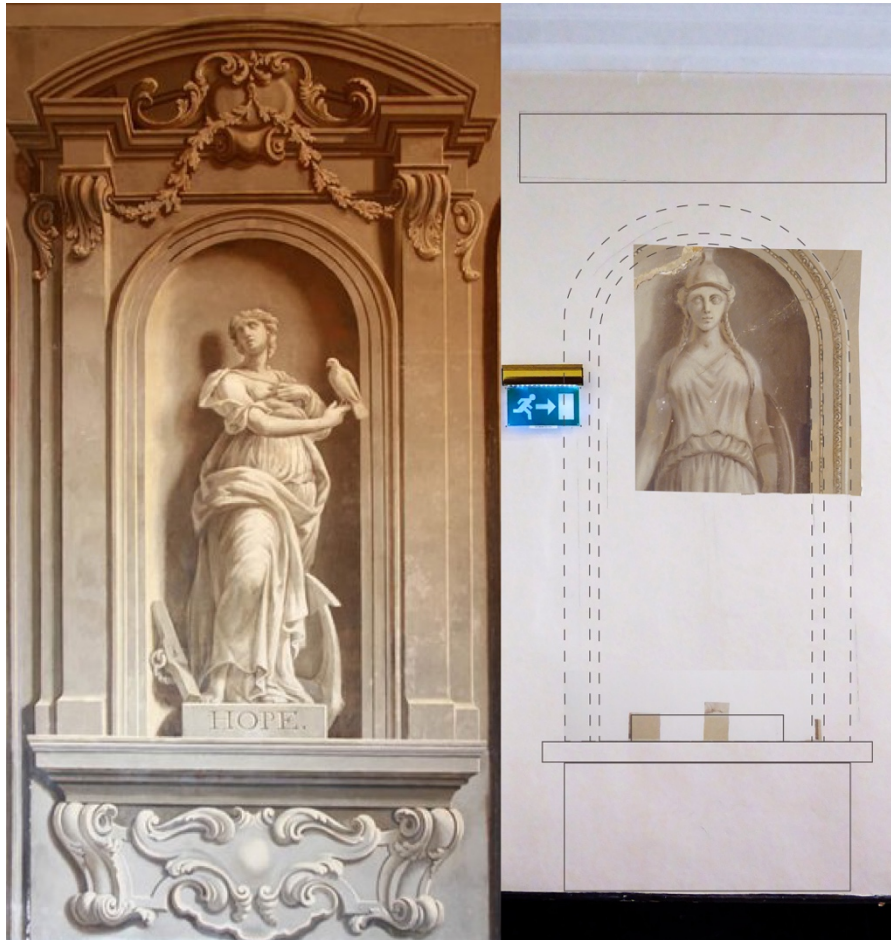
Figure 16: A comparison between the figure of Minerva found at Stowe (above right) and the grisaille painting of Hope at St Lawrence Church by Sleter (above left) © London churches in Photographs and Hirst Conservation, 2016. Note the similarities between the niches and modelling.

Even if the wall paintings are known to be contemporaneous with the ceiling painting by Sleter, there is no firm attribution for the wall paintings, other than Seeley's 18th century description, although Sleter is the most likely as he had numerous commissions throughout the house and garden buildings at Stowe. Furthermore, the stylistic similarities to another of Sleter's known commissions at the Parish church of St Lawrence, Little Stanmore are striking (figure 15), and hints at the splendour that might once have adorned the walls of the East staircase at Stowe.

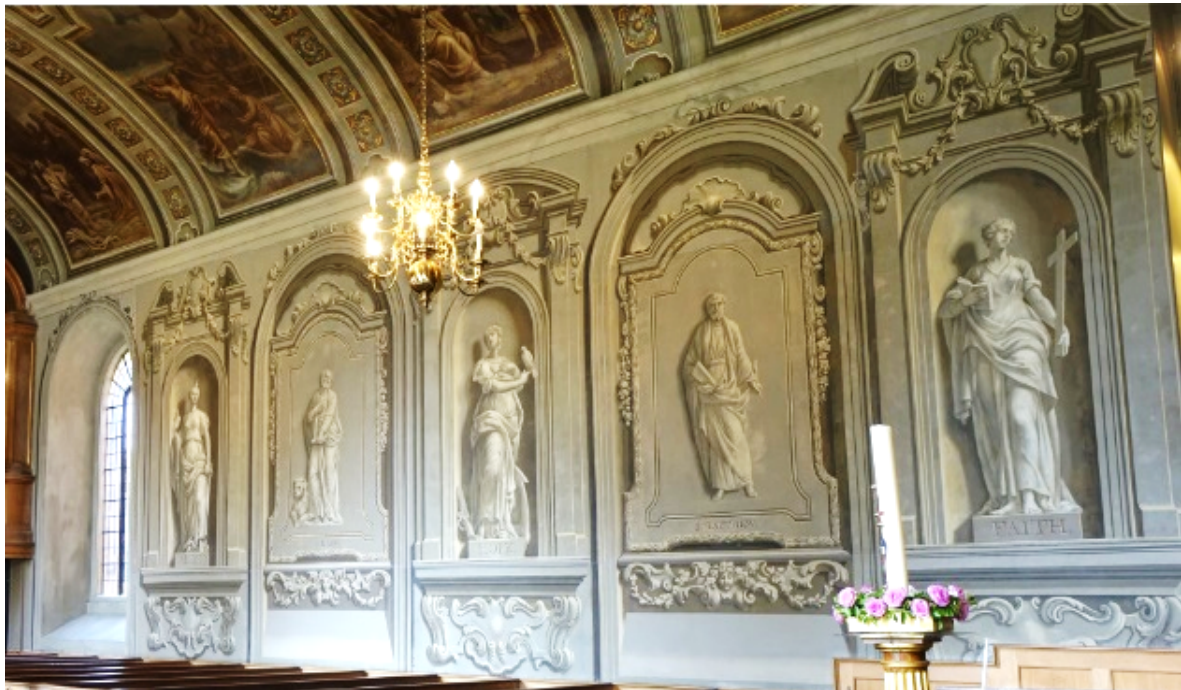
Figure 17: The North Nave wall at the Parish church of St Lawrence, Little Stanmore, with grisaille paintings by Sleter © London Churches in Photographs

The walls of the Nave at St Lawrence church are covered with grisaille paintings of the Evangelists and fictive trompe l'oeil paintings of statues of the cardinal virtues in a series of niches, which date to c1736 (figures 16 and 17). The Nave walls were previously attributed to Laguerre, but have since been reattributed to Sleter, possibly in collaboration with Brunetti, due to similarities between them and the inset grisaille paintings at Moor Park [Croft-Murray, p279].

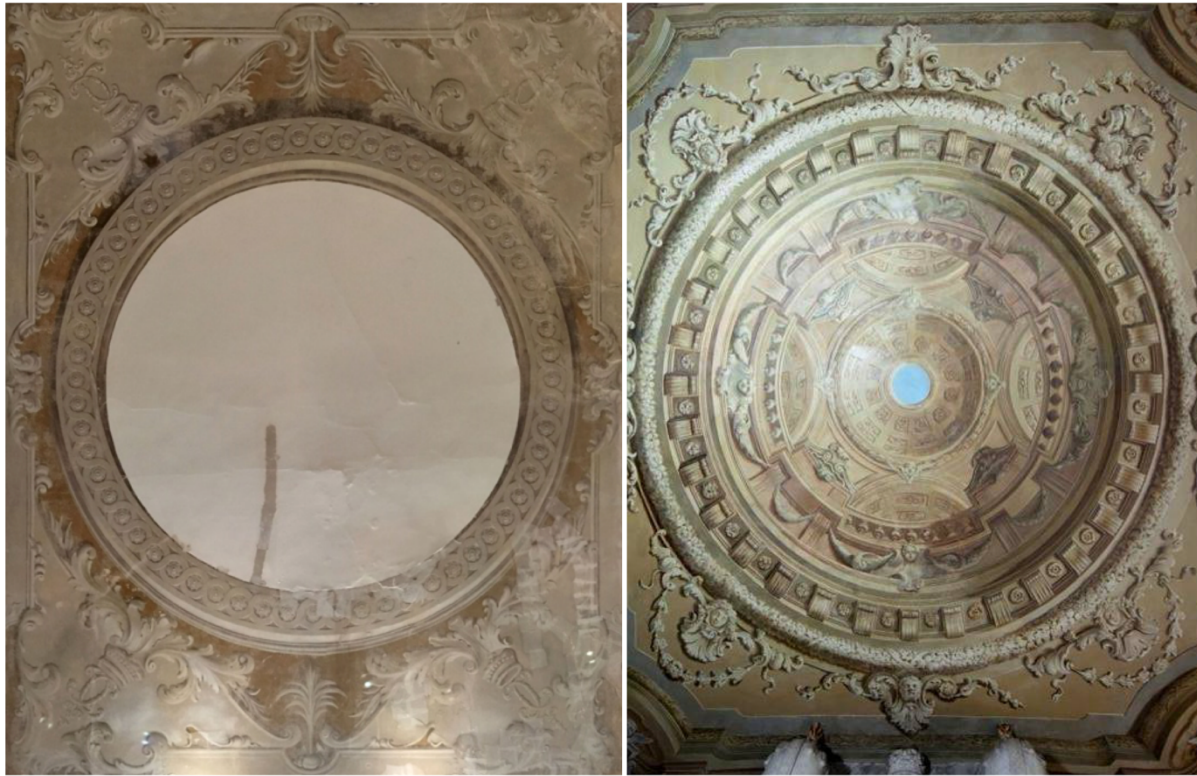
Figure 18: (above left) The trompe l'oeil ceiling above the upper landing at Stowe with its missing central composition, compared to the ceiling of the Chandos Mausoleum at the Parish church of St Lawrence, Little Stanmore by Brunetti (above right) © ipernity 2015

It is possible that Brunetti may have had a hand in the paintings at Stowe, although a lack of archival evidence and the fact that he moved to Paris in 1739 due to financial difficulties [Croft-Murray, page 176] may preclude this. One might also speculate that the historic appearance of the ceiling above the upper landing may have been similar to the ceiling of the Chandos Mausoleum, which comprises a trompe l'oeil dome surrounded by painted quadratura (see figure 18). Equally, the central oculus could have been filled with one of Sleter's missing allegorical paintings of *Justice and Peace* or *Plenty and Constancy*.
